Elevator Door Detector Light Curtains and Related Door-Closing Injuries

An increase in incidents prompts this examination and explanation of door protection devices.

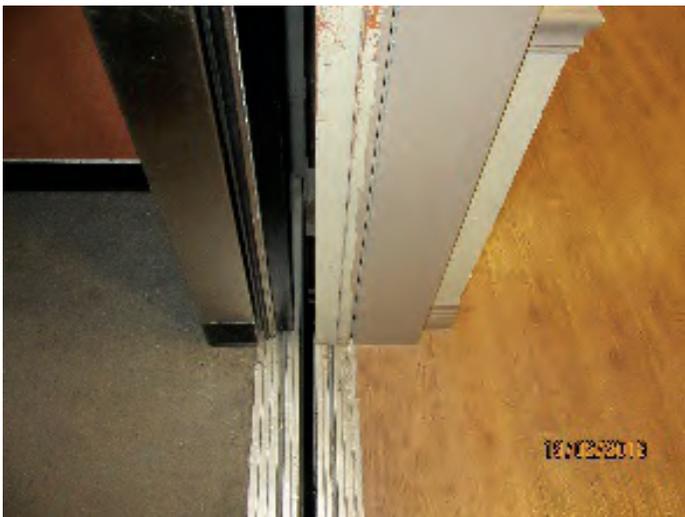
Figure 1

On some elevators, a person's hand or foot would have to project 4-7 in. past the leading edge of the hoistway door to interrupt the door detector beams and activate the controls to reopen the door (Figure 1). We have encountered several injuries in which a person's hands or feet, which had not yet projected into the entrance to reach the car door sensors to break the beams, were injured by the hoistway doors closing.

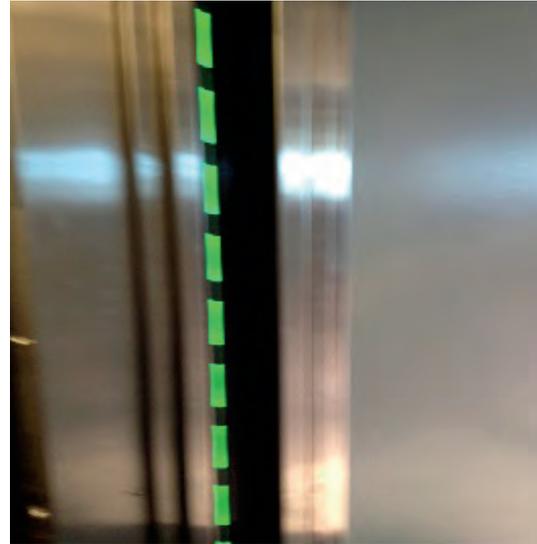
Figure 2

These new-generation 3D edges look for moving targets in front of the hoistway doors and entrance areas, and sense when an object or person is approaching the elevator. Additionally, some manufacturers provide 2D door detectors with flashing colored LEDs on the leading edge of the car door detector. These

flashing lights are red or yellow for closing, and green for opening (Figure 2). This visually alerts passengers when the doors are in the opening or closing cycle, and offers additional passenger protection from them.
